LEVELTON CONSULTANTS LTD.

Memorandum

Re: Marine Drive East Side
Slope Assessment

Project #: R714-0951-00

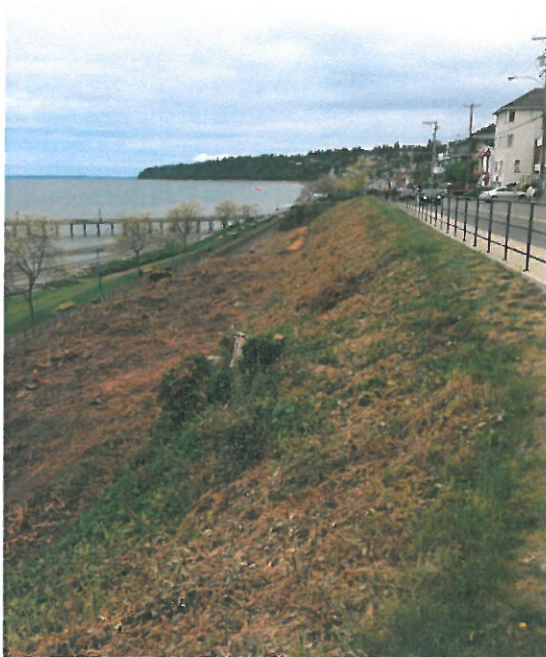
On 13 May 2015, Levelton visited the site with Paul Slack, Bob Ambardar, P.Eng. and Hiep Lo of the City of White Rock to conduct the visual review of the slope. At the time of visit, a contractor was clearing trees and brush from the west side of the slope and progressing to the east (Photograph 1). The native soils observed along the slope surface consisted of a stony glacio-marine material comprised of sandy silt and gravel. The sandy silt and gravel was observed in one particular area of cleared slope, the soils may vary along the slope. Levelton did not observe any signs of instability on the cleared slopes.

Photograph 1. Cleared slope looking west

- To minimize the potential of slope erosion to the exposed soil areas on the cleared slopes should be hydro-seeded;
- A secondary assessment of the hydro-seeded slopes should be conducted in the winter months to review the effectiveness of the hydro-seeding, re-seeding could be required;
- Levelton is reviewing the trees east of the Eagle tree conservation area on May 22nd and will advise if any further tree removal is needed due to stability concerns;
- The tree located directly south of the deteriorating wood retaining wall across from 15191 Marine Drive should be removed prior to initiation of the retaining wall remedial works. The tree may cause complications with the installation of the micropiles;

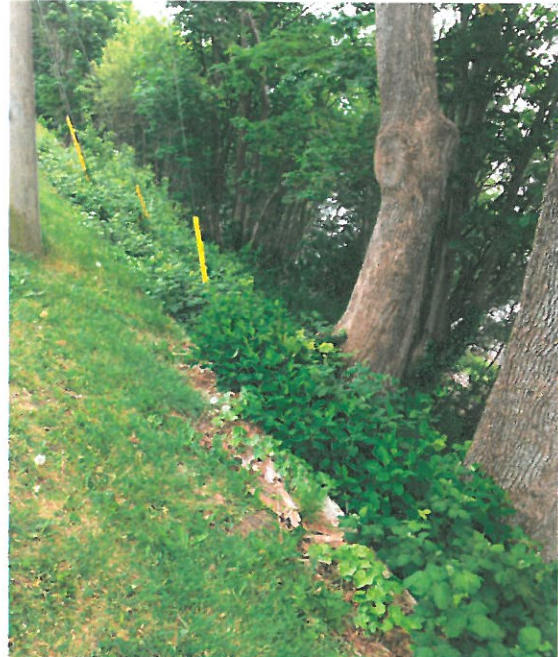
Photograph 2. Tree in front of wood retaining wall

- The cutting of the tree (Photograph 2) will not pose as a geotechnical hazard provided that the deteriorating wall is rehabilitated as per Levelton design drawings (R714-0951-00);
- We request that the brush around the deteriorating wood retaining walls is cleared prior to construction;
- Levelton is to conduct a detailed review of the wood retaining walls upon clearing of the brush and trees surrounding the walls.
